# EXPLORING THE MECHANISM AND LONGEVITY OF CORROSION INHIBITORS IN INSULATION

## ABSTRACT

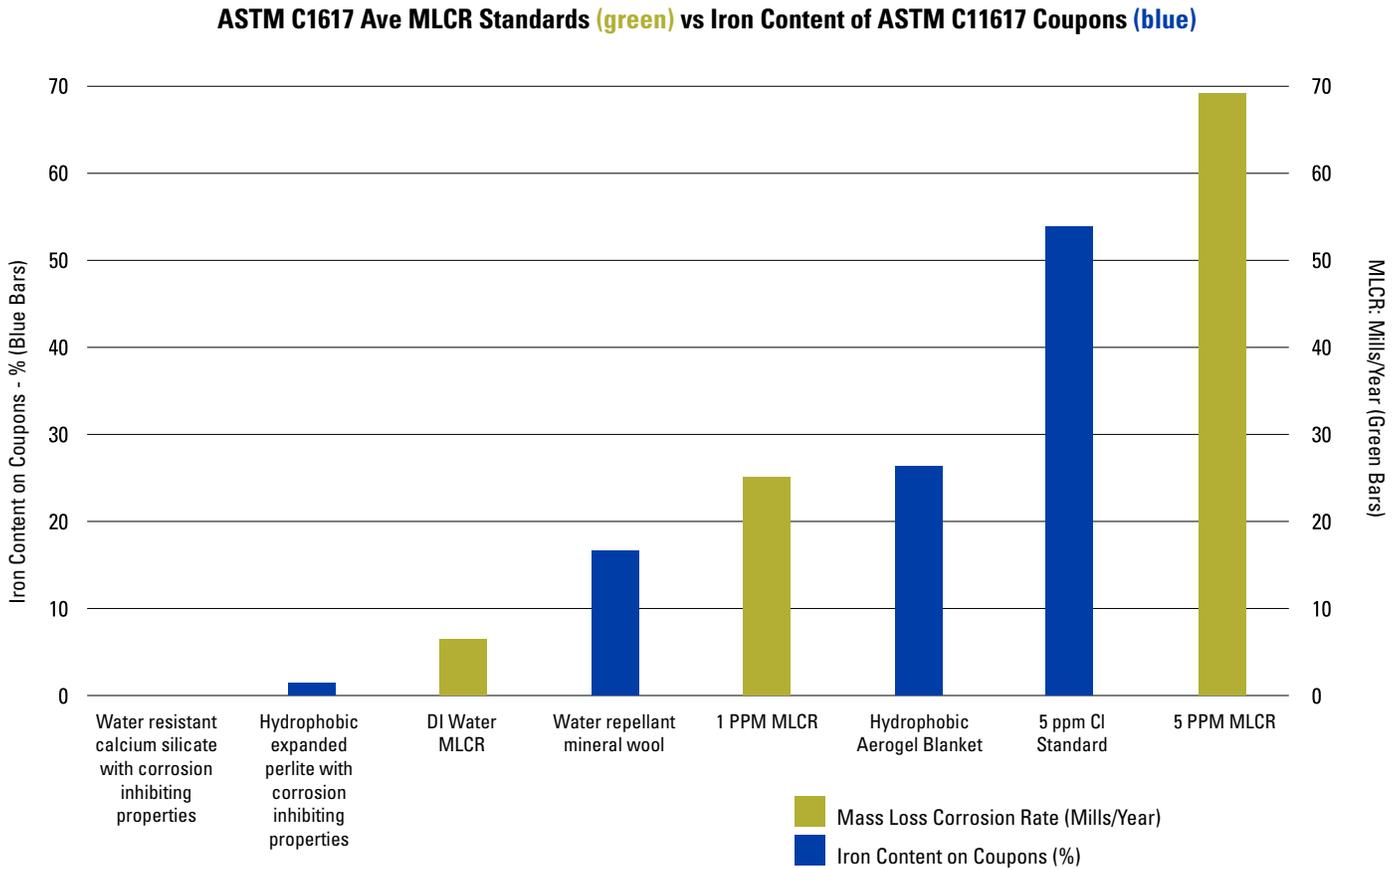
FIGURE 1: Mass Loss Corrosion Rate of Standards using ASTM C1617

For the various insulation types, the relative concentration of iron or iron oxide in the samples corresponds to the relative performance of the insulations using the ASTM C1617 corrosion test method. The iron oxide (column Fe) present in the analysis is the formation of rust or generalized surface corrosion. The ASTM C1617 test compares the relative corrosivity of the insulation leachate to three standards/controls: deionized (DI) water, 1 ppm chloride solution, and 5 ppm chloride solution. Figure 1 shows the representative relative average mass loss corrosion rate (MLCR) of the standards used in the testing protocol.

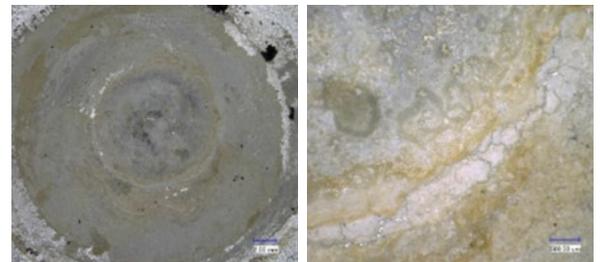
FIGURE 2: Enhanced imaging of metal coupons after ASTM C1617 test method using Thermo-1200 water resistant calcium silicate with XOX Corrosion Inhibitor sample.

Figure 2 shows there is no corrosion on the surface of the calcium silicate coupons. The buildup on the surface is consistent with the protective silicate and ion layer identified in the EDS analysis. The silicate and ion layer on the surface is acting to prevent the corrosion damage to the surface of the coupons.

The EDS analysis of the samples of the Thermo-1200 and Sproule WR-1200 with the XOX Corrosion Inhibitor revealed that the calcium silicate had no iron on its surface (0.0%) and the expanded perlite had a negligible amount of iron (0.91%). Additionally, both materials exhibited less corrosion than DI water in the ASTM C1617 analysis. In contrast, the MinWool-1200 and hydrophobic silica aerogel blanket samples had the highest relative concentrations of iron, 16.9% and 26.4%, respectively. As a comparison, the 5 ppm chloride standard tested had a relative iron concentration of 54%.

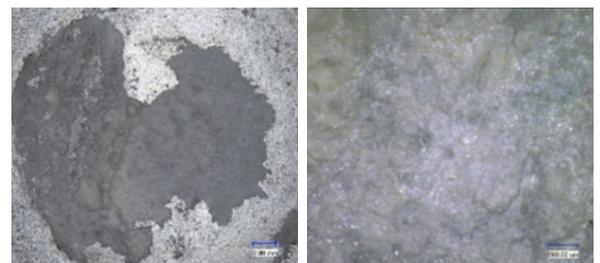
FIGURE 3: Enhanced imaging of metal coupons after ASTM C1617 test method using Sproule WR-1200 hydrophobic perlite with XOX Corrosion Inhibitor sample.

Figure 3 shows there is no corrosion on the surface of the perlite coupons. The buildup on the surface is consistent with the silicate and ion layer identified in the EDS analysis. Again, this layer on the surface is acting to prevent the corrosion damage to the surface of the coupons.

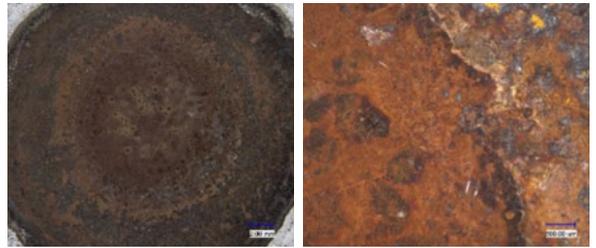
**FIGURE 4:** Enhanced imaging of metal coupons after ASTM C1617 test method using hydrophobic silica aerogel blanket sample.

Figure 4 shows a layer of iron oxide or rust on the surface of the coupon. No protective sodium silicate layer or carbon buildup is present.

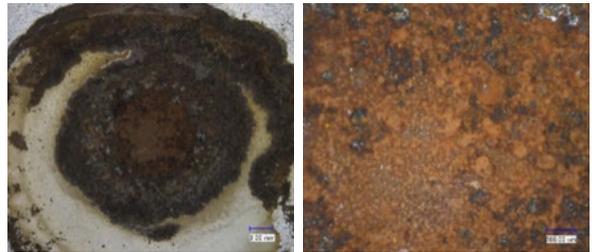
**FIGURE 5:** Enhanced imaging of metal coupons after ASTM C1617 test method using MinWool-1200 water repellent mineral wool sample.

Figure 5 shows a layer of iron oxide or rust on the surface of the coupon. No protective sodium silicate layer or carbon buildup is present.
